# Krakow Fortress. Fort 47. Łysa Góra – state of preservation, prospects and threats

Aneta Gołębiowska-Tobiasz – Paweł Kalisz

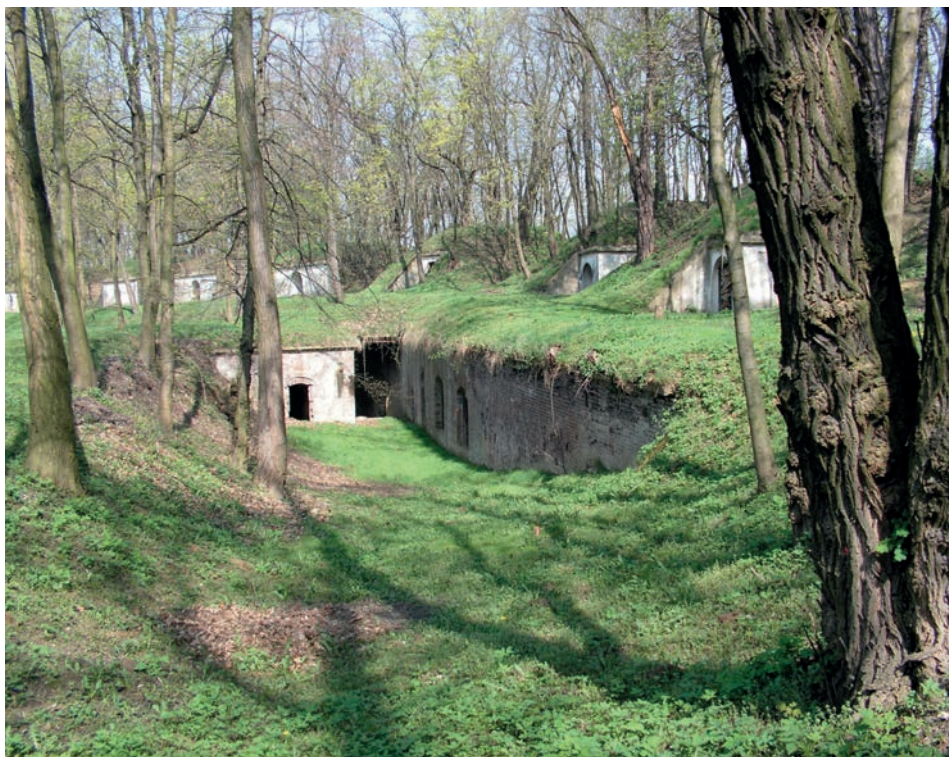
Fig. 3 A vaulted brick shelter located in the inner slope of the embankment – view of the eastern part.

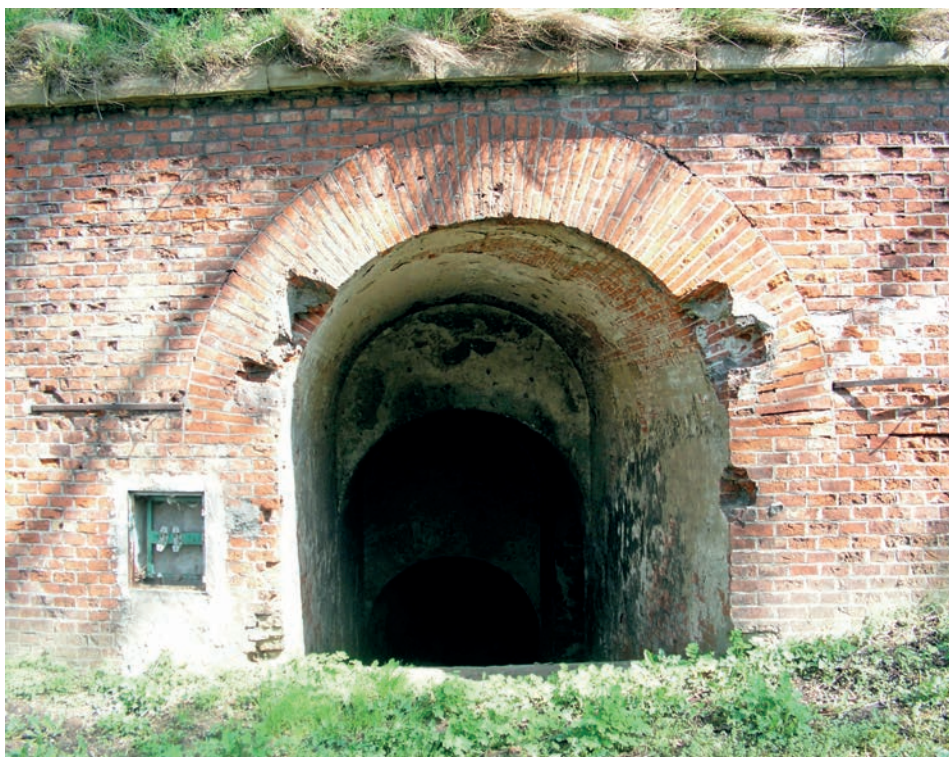
Fig. 4 Entrance to the postern (underground pavements).

The Fort No. 47 was initially constructed as a single-rampart, barkan-shaped, semi-permanent artillery fort with a focus on distant defense. The building is pentagonal in plan. The first element to be erected was a steep artillery rampart with an underground shelter housing a powder magazine and artillery laboratories (Fig. 3). A postern (underground pavement) was designed in the axis of the underground shelter, leading to the double frontal caponier (Fig. 4). The caponier is symmetrical in plan.

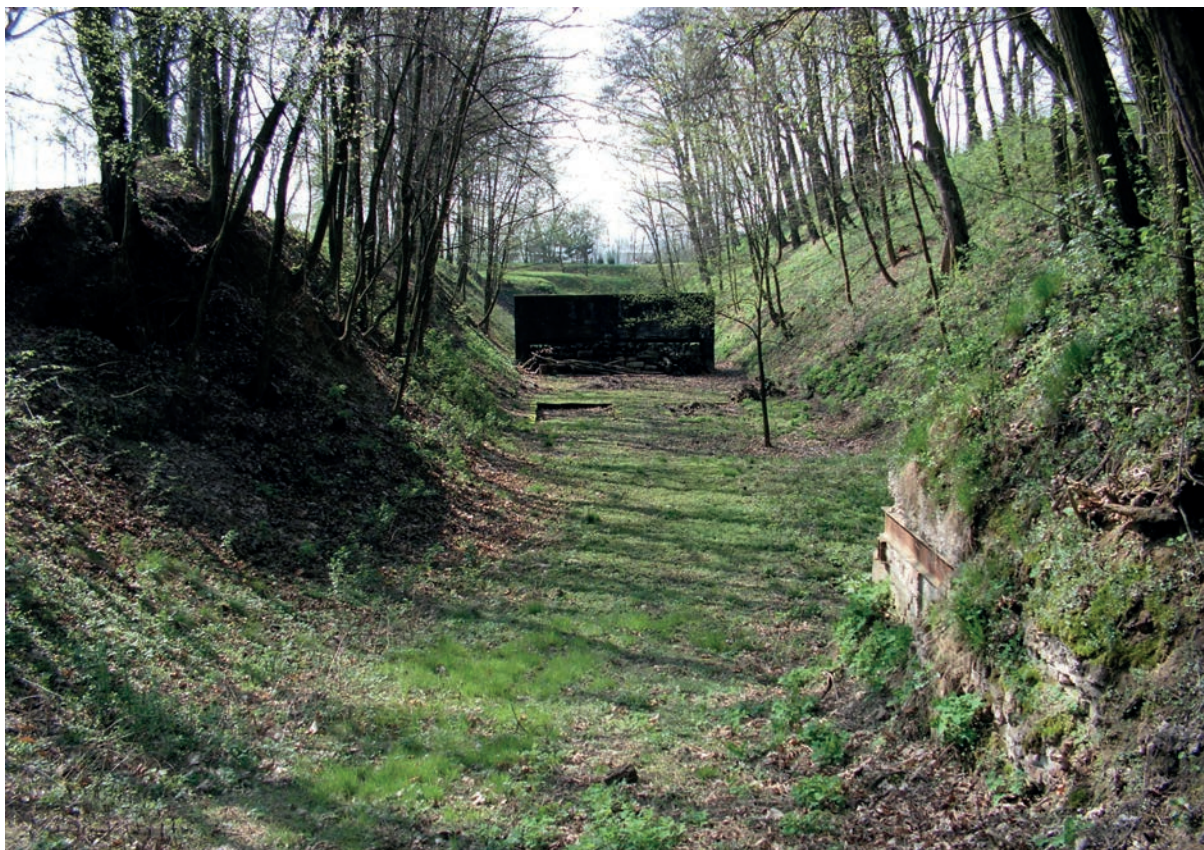
Fig. 5 Left: double front caponier. The plan shows a dry moat and a shooting range from the end of the 20th century.

There were positions for four cannons and 23 gunners (Fig. 5). The side posterns served as a connecting route between separate side caponiers, each of which had two guns and ten gunners. (Fig. 6). The caponiers of the “Łysa Góra” fort are larger than those of the later forts of this period. The fortification was surrounded by a narrow, dry moat with a fortified counterscarp. The neck barracks were most likely also built in this phase of construction. They are asymmetrical, broken with a semi-bastion (Fig. 7, 8). The sides of the semi-bastions housed the cannons, defending the neck moat. A telephone exchange, food storage, latrines, and quarters for the commander and officers were all located in the barracks. The barracks were connected by walkways, leading the infantry to the central casemate block and to the level of the rampart road (Fig. 9). The walkways were closed with armored doors, provided with loop holes. The neck barracks were connected to the central casemate block by a passage hallway, which lead into the entrance of the main postern (Fig. 10). In the next construction phase, the central casemate building was erected. It was connected to the guardhouse block via the main postern (Fig. 11). The interior of the building had an enfilade structure (Fig. 12), combining spaces for utility purposes, as well as kitchens, baths, two wells (Fig. 13), and living quarters for the soldiers. Latrines were located in the wings. The entrance gate to the fort was located on the main axis of the neck barracks. It was closed by a double, double-leaf armoured gate, with loop holes and an additional wicket in the outer gate (Fig. 14). In front of the gate was a bridge, crossing a shallow moat. The gate was protected by a pre-gate wall with 24 embrasures (Study 2004, I.1.4). The reconstruction phase of the 1880s gave the complex the character of a permanent fort (Fig. 15).

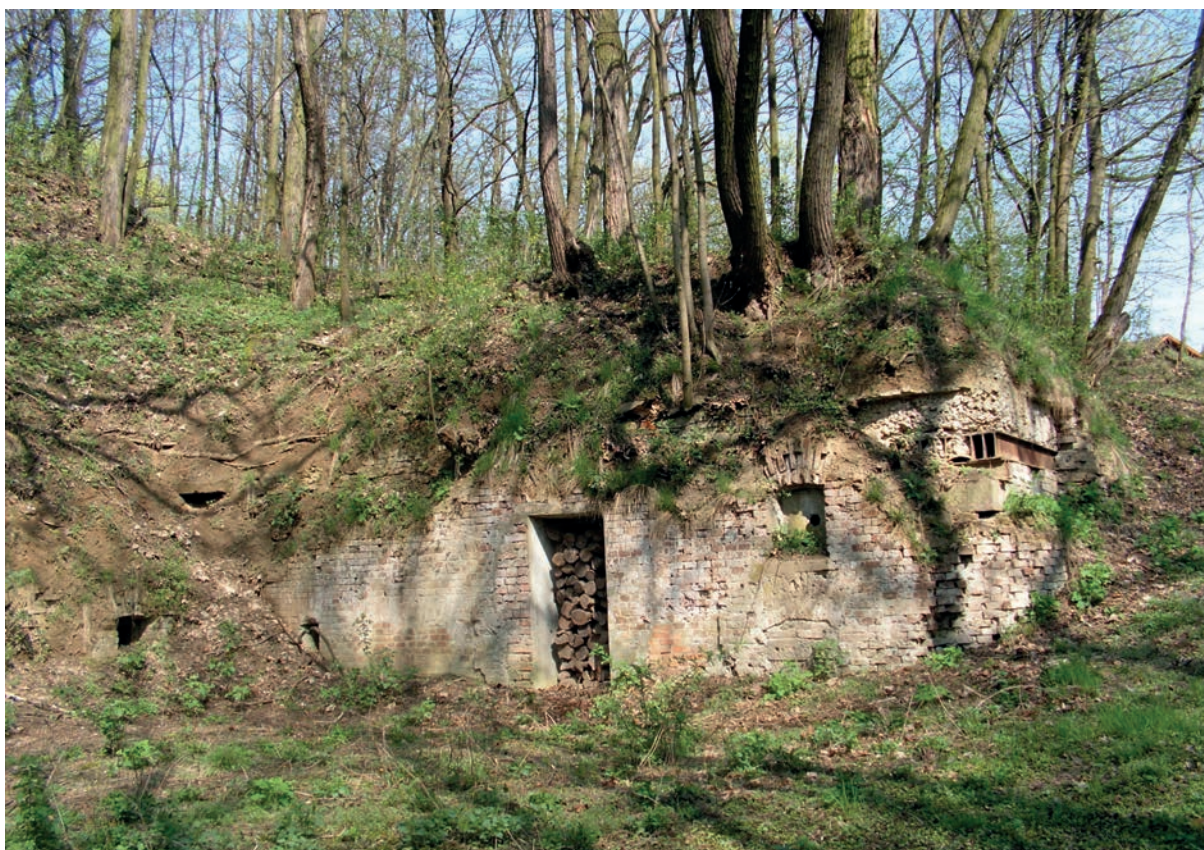
Fig. 6 Eastern side caponier.

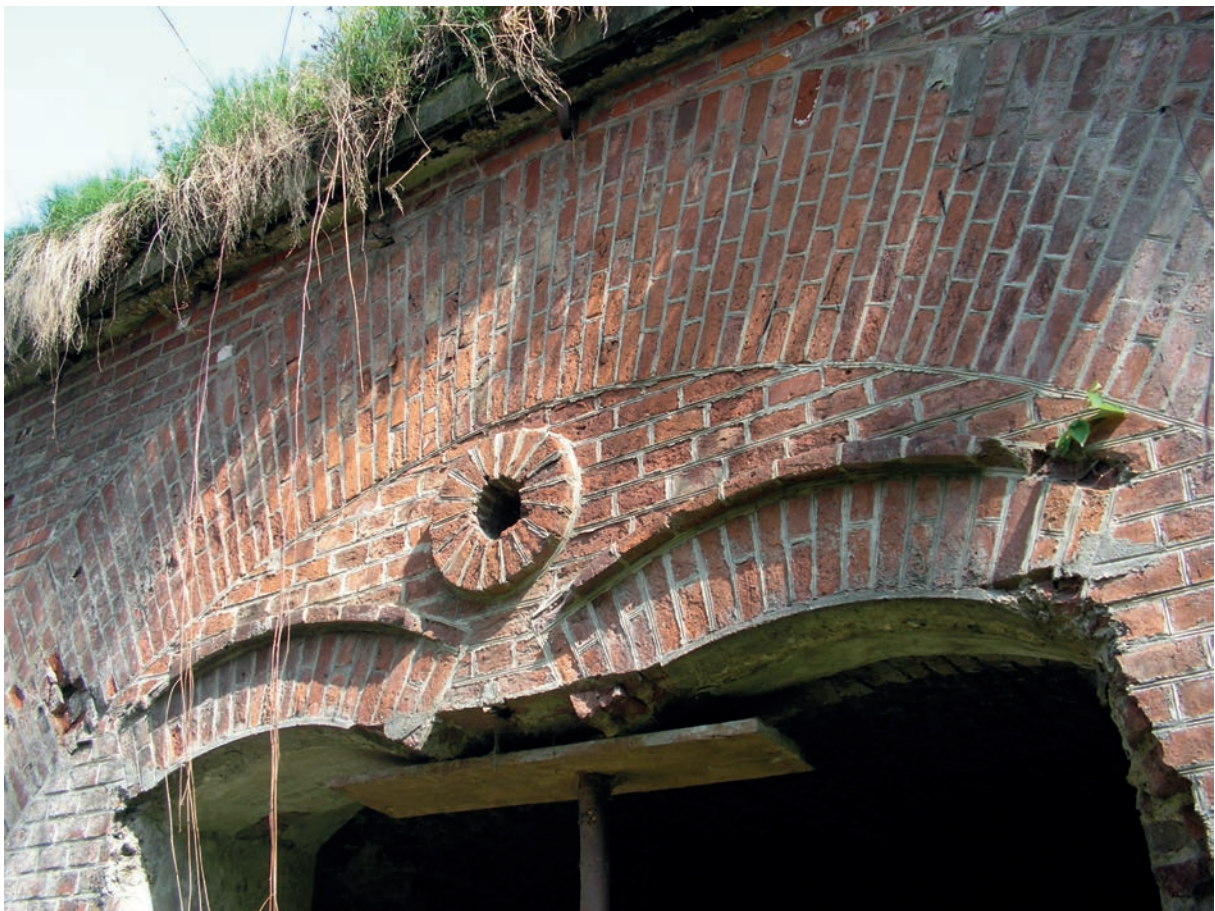
Fig. 16 Elevation bricks above the entrance to the central casemate block – detail.

The fort was built of bricks. The central casemate block, the neck barracks and the frontal underground shelter were made entirely of them. Interestingly, the underground shelter was used as a powder magazine, but it was not considered necessary to reinforce the structure. The bricks used for the interiors of the barracks were covered with plaster, while the external walls of the buildings were made of weather-resistant facade bricks. It is worth noting that, despite the severity of the construction and the fort's primarily defensive functions, the attention to aesthetic detailing is evident in many places. The military engineers did not forget that there would be people inside the fortress and that the surroundings would influence their behavior. The facades of the barracks were soundly and sturdily made, but with a great sense of aesthetics. The deliberate use of bricks as an ornamental element is evident. The ornamental motifs were carefully designed (Fig. 16, 17). Similarly, structural elements made of sandstone, such as the window and door jambs, are not only functional but also represent a distinct decorative value (Fig. 18). Only the shelters, the vaults in the powder magazine, some of the vaults in the caponiers, the gunner's annexes and the ammunition storages were made of concrete. The underground shelters and posterns were also made of concrete. The vaults in the soldiers' dwelling quarters were constructed of concrete, but the walls were made of bricks. Concrete was also used to construct the lintel arches in the passageways between the rooms and the end sections of the posterns. The thickness of the walls ranged from about 1.00 to 2.00 m. The cradle vaults were approximately 1.00 to 1.20 m thick (Study 2004, I.1.4).

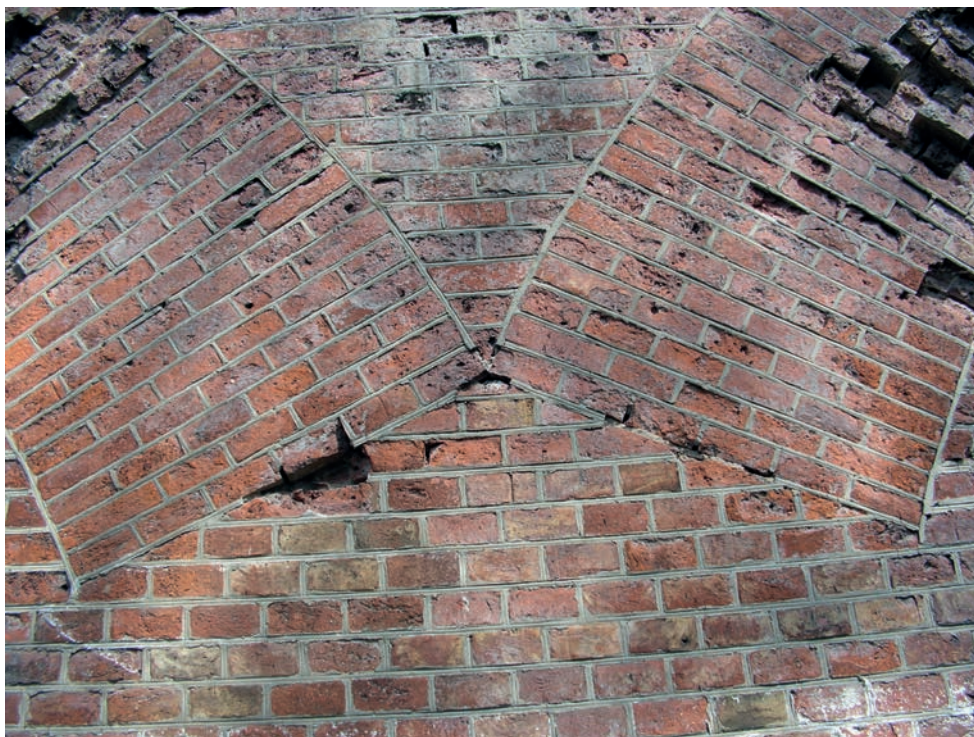
Fig. 17 Elevation bricks – on the facade of the central casemate block.

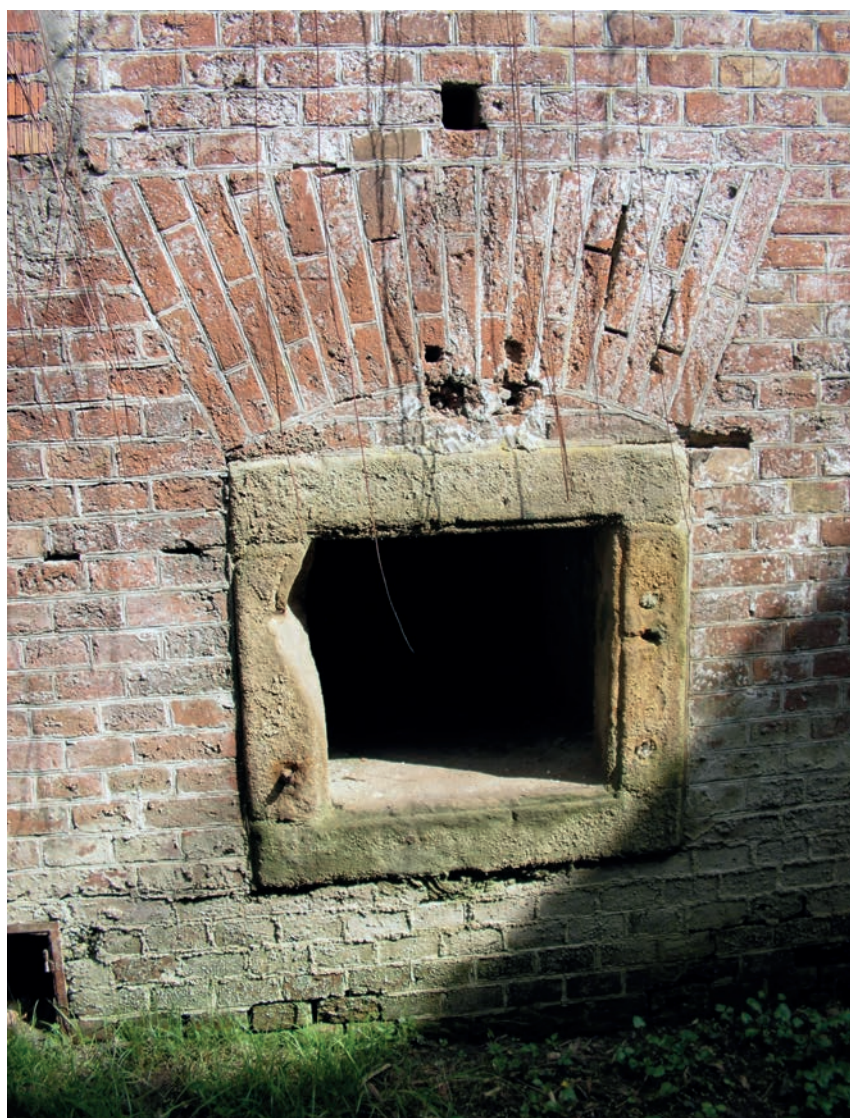
Fig. 18 Sandstone used to finish the window frames.

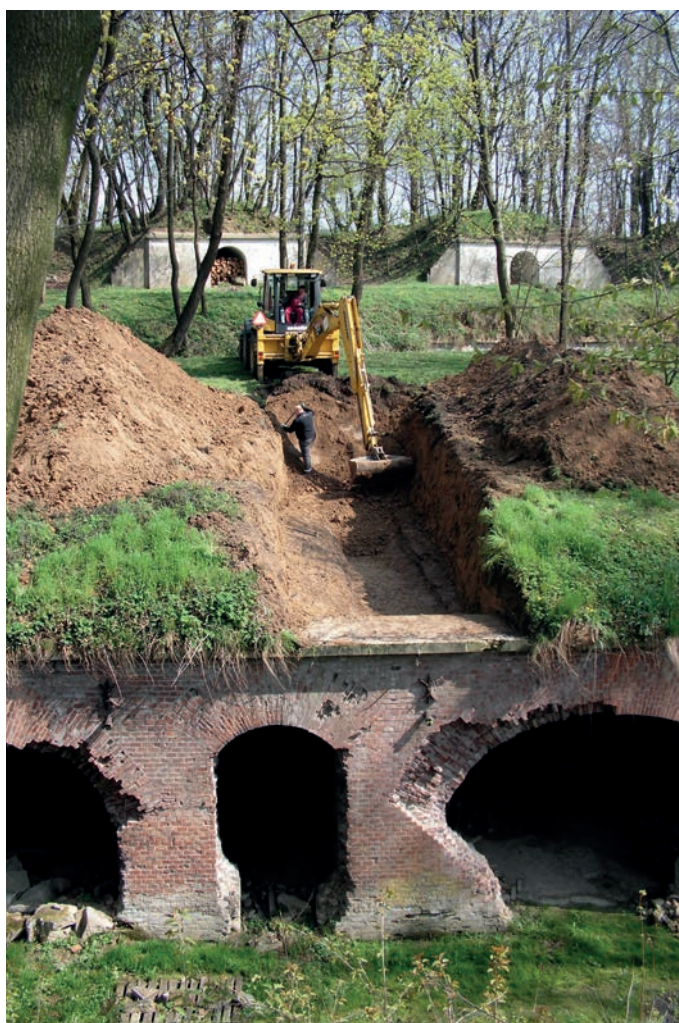
Fig. 20 Dumping of secondary layers over the western shoulder of the central casemate block.

In the same year, probing archaeological investigations were carried out. This included the mechanical sifting of secondary earth embankments covering structural details along the axis of the main postern, between the neck barracks and the central casemate block (Fig. 20). The survey work was carried out over the western wing of the casemate barracks block, along the axis parallel to the postern. The humus, which was approx. 0.30 m thick, was removed in layers mechanically with an excavator, up to the level of the top part of the barrack ceiling. This constituted a covering profiled in line with the course of the vaults, protected by a glued-layer approx. 0.20 m thick. The ceiling of the vaults appeared at a maximum depth of 2.00 m. A 3.00 m long, 1.00 m wide cornice was exposed in the front part of the development. Before reaching the level of the roof, excavator work was stopped and further excavation was continued manually, removing the last backfilling layer. After it the roof level was thoroughly cleaned and prepared for photographing and geodetic survey. The

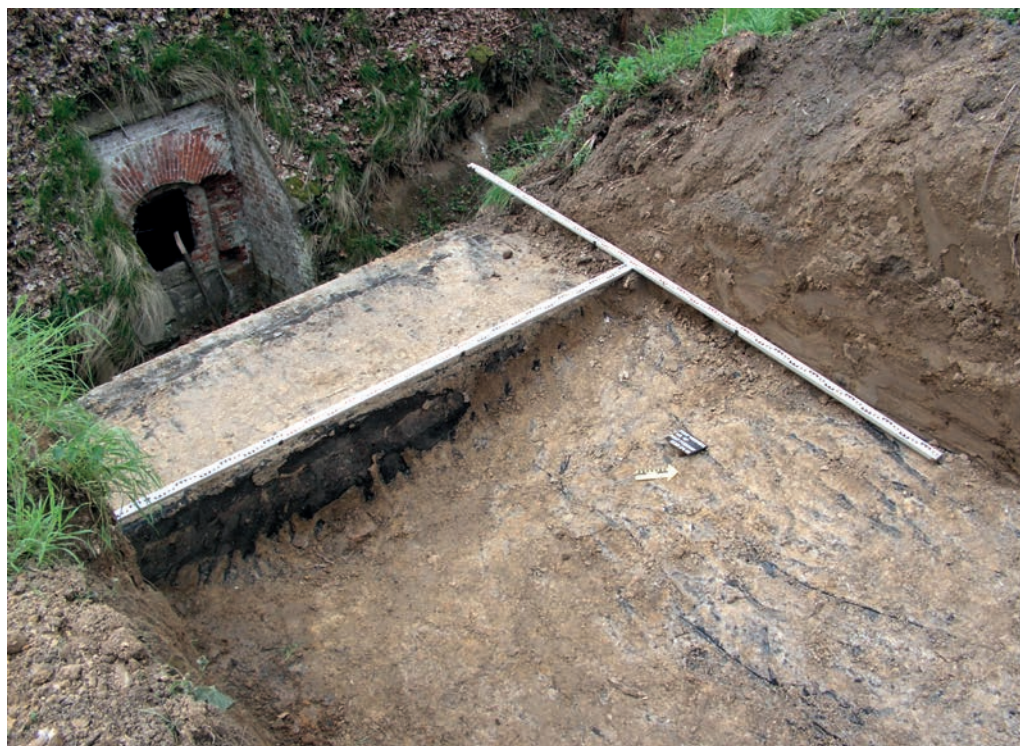
Fig. 22 View of the cornice.

While carrying out clearing work on the ceiling of the structure, a sort of quadrangular-shaped ceramic stopper measuring 0.15 x 0.15 m was discovered along the inner edge of the cornice, closing off the access to the drainage, visible below the cornice face on the south side of the building block (Fig. 22).

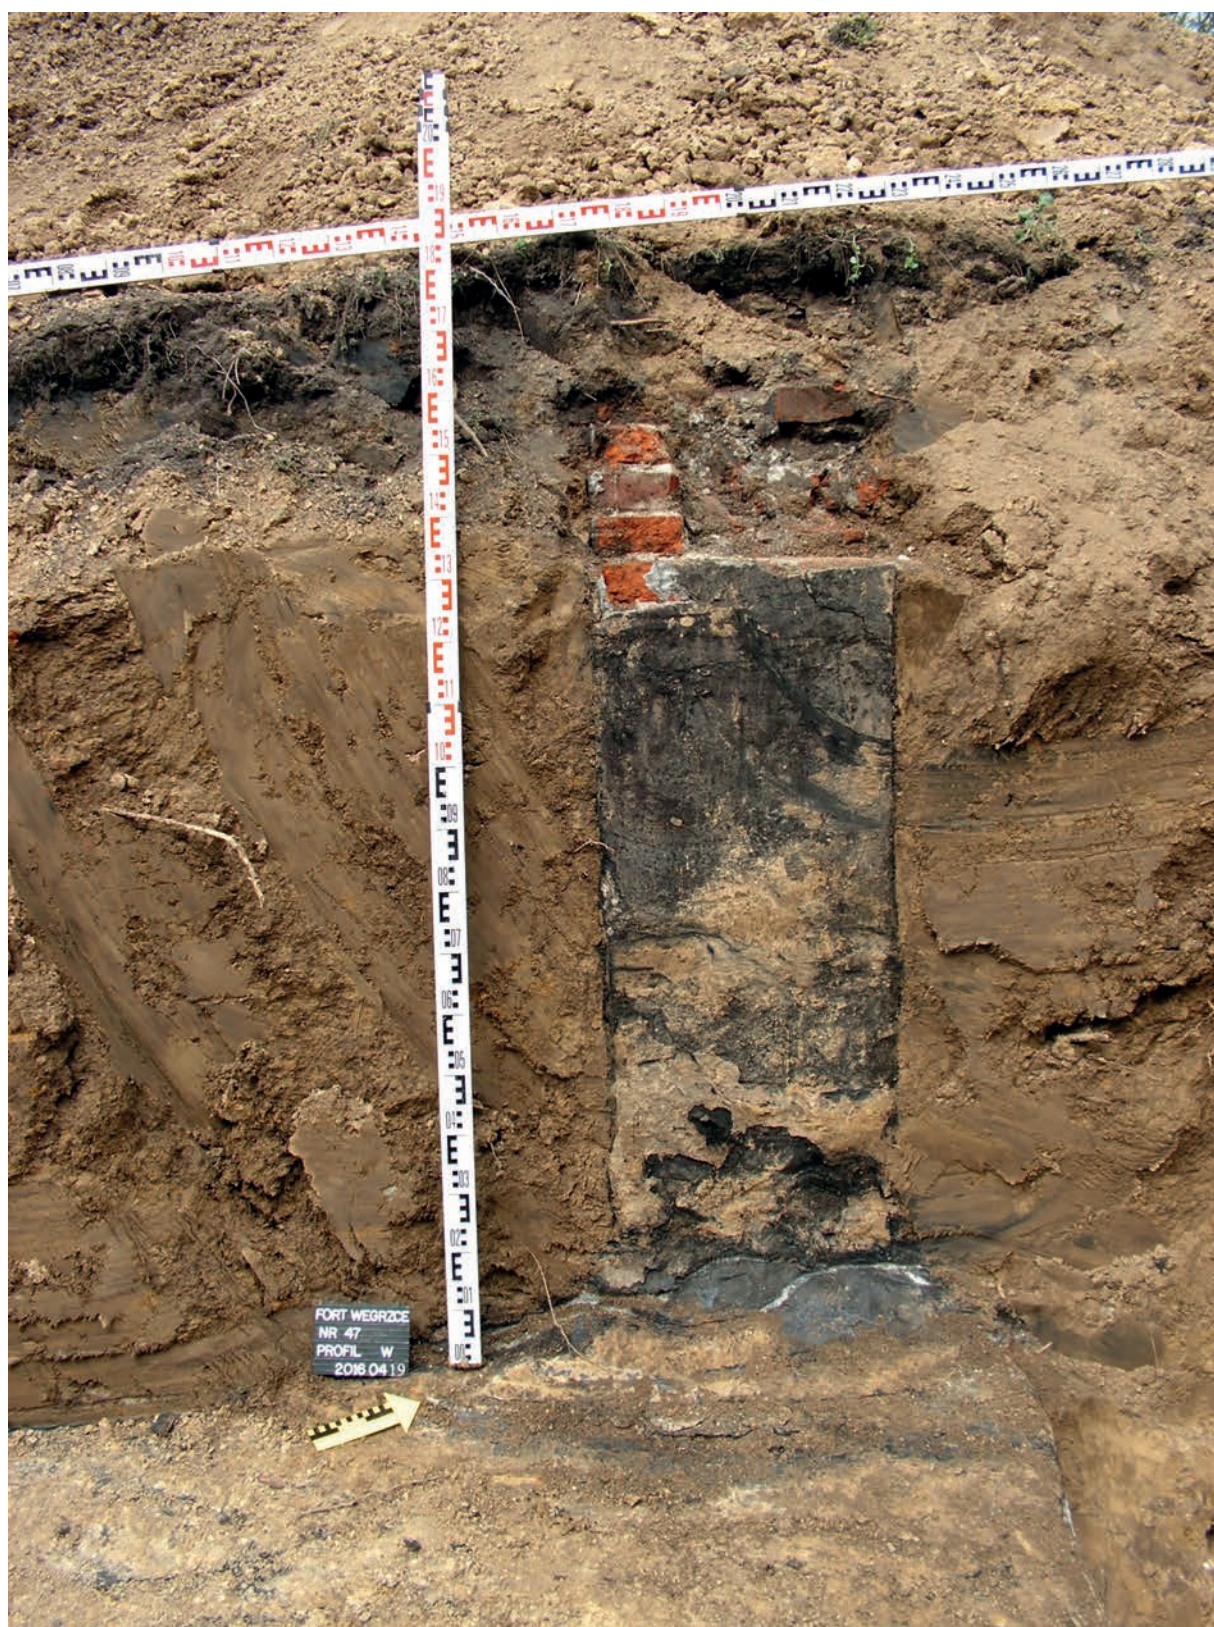
Fig 23 Fragment of the ventilation duct.

In addition, in profile W, between 12 and 13 meters of the trench from the face of the barracks development, the east wall of a surviving brick ventilation shaft was found, which was cleaned and documented in photographs (Fig. 23). The structure was not disturbed. It was located at the edge of

the barracks ceiling. The height of the shaft was 0.80 m and the width was 0.50 m. The walls were smeared with a compacted layer of sticky substance. The upper part consisted of bricks, laid in format of stretcher bond towards the edge of the side wall. The heads of the second row of bricks were visible in profile. Survey measurements were taken on the detachment, measuring the bottom and edges of the trench, as well as measuring the trench and ceiling.

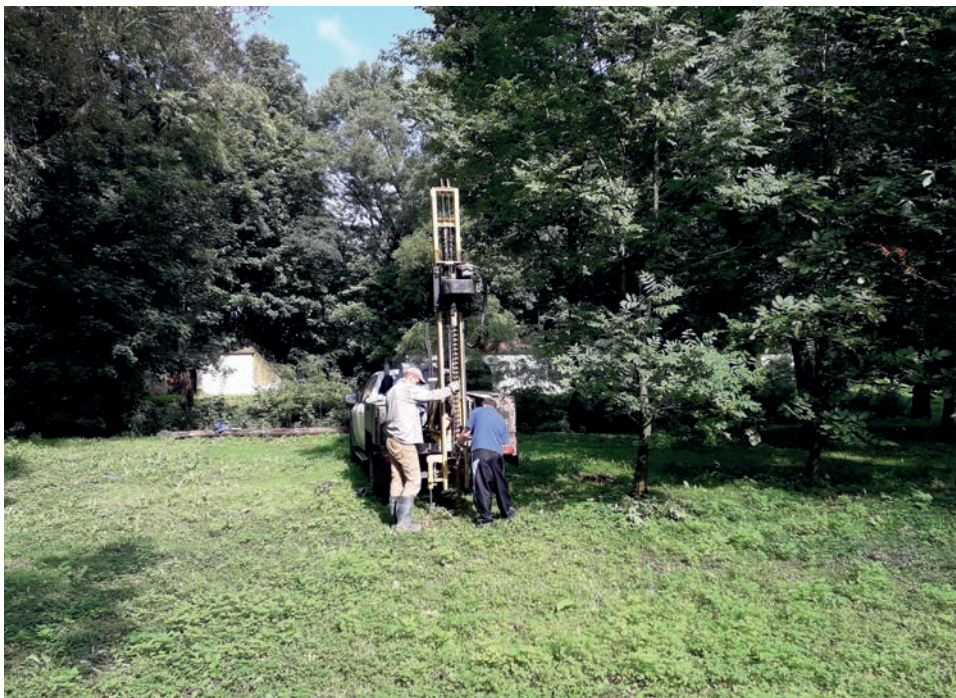
Fig. 25 Borehole number 2.

The well No. 2 had the following stratigraphic layers: from ground level to 3.00 m, the layer consisted of light brown compacted dust (especially to a depth of 1.00 m was characterized by strong compactness). From the 3.00 m to 6.00 m level, a layer of brown silty clay with a slightly compacted, sticky fraction appeared. From a depth of 6.00 to 7.00 m, the layer was heavily compacted brown clay that continued to the 9.00 m level. From 9.00 to 10.50 m, limestone pebbles appeared in a layer of brown, compacted clay. From the 10.50 to 12.00 m level, debris appeared in the clay. The well No. 2 was finished at a depth of 13.50 m. All layers were natural in nature. Samples were taken from all levels for geological studies (Fig. 25).
