# Downfall of the Rokštejn castle in 1467

**Abstract:** *The Rokštejn castle has played an important role in the political history of the Bohemian-Moravian border during the Middle Ages. From its humble beginnings as a seat of local noble family, from which the castle bears its name, through the Margravian phase, during which the castle was rebuilt and gained its two-palaced schema, to the Waldstein ownership, which later meant its demise, as the Waldstein family's political orientation became one of the precursors for a larger military conflict which became known as the Bohemian-Hungarian War (1468–1478). The evolution of the castle from the half of the 13th century to the 1467 is reflected here to assess the military strength of the castle and the possibilities of its inhabitants/defenders during the last siege of the castle in 1467.*

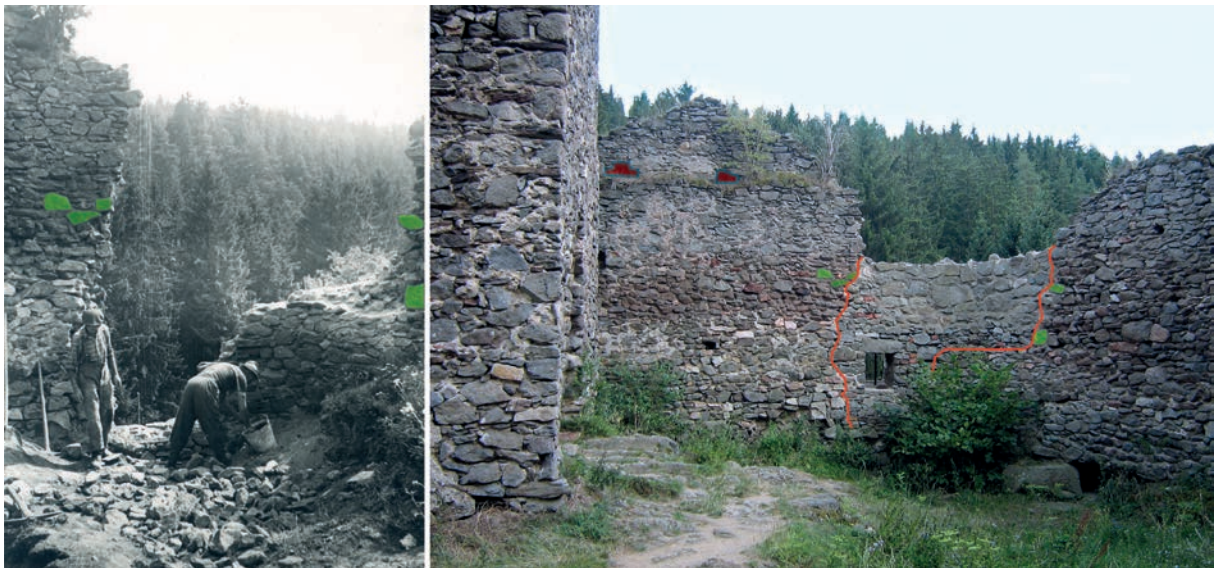
Fig. 7: The Mantelmauer of the Upper Castle. Left – original state of preservation in the 1960s. Right – contemporary situation after amateur preservation works.

The still existing parts of the Upper Castle's *Mantelmauer* (Fig. 7) represents a destroyed wall with modern alterations and renewals from the 1960s and the 2000s. The *Mantelmauer* bears quite a few footprints of historical rebuilding. The first phase of the wall had 2m in width, and was built by the first owners, the Ruthensteiners. At the beginning of the 14<sup>th</sup> century (after 1306/1307) it was dismantled, and the vestiges of it used as a foundation for the second phase of the wall. This *Mantelmauer* had, at least in its southern part, *chemin de ronde* (or a wall-walk) with a battlement (Fig. 8). This defensive arrangement of the wall cannot be found on the western part, facing the valley, and we must presume, it had no active defence. Third phase is then representing the construction works of the second owner, the Moravian Margrave, who, during the second half of the 14<sup>th</sup> century raised and widened the wall, effectively concealing the older battlement. This phase could possibly have been built during the ownership of the last nobles, the Waldsteiners, at the beginning of the 15<sup>th</sup> century, who were also heavily modifying the castle's appearance. But as the Waldstein Family added the *Zwinger* wall around the entire castle, the defensive importance of the Upper Castle's *Mantelmauer* was lessened.

destruction (Fig. 7 and Fig. 8). Another change to the castle's architecture is of opposite nature. The gate of the Lower Castle was walled-in, in order to prevent the intruders to get inside the castle, so we can see a change being done by the castle's garrison. By doing so, the defenders lost the possibility of using the *Zwinger* wall with its wall-walk and battlements. Yet, as the *Zwinger* wall was lower in most instances than the siege positions, the battlement became inefficient anyway, and the possibly low numbers of defenders of the castle could do very little against the obvious disadvantages the attackers had, that is the landscape itself.

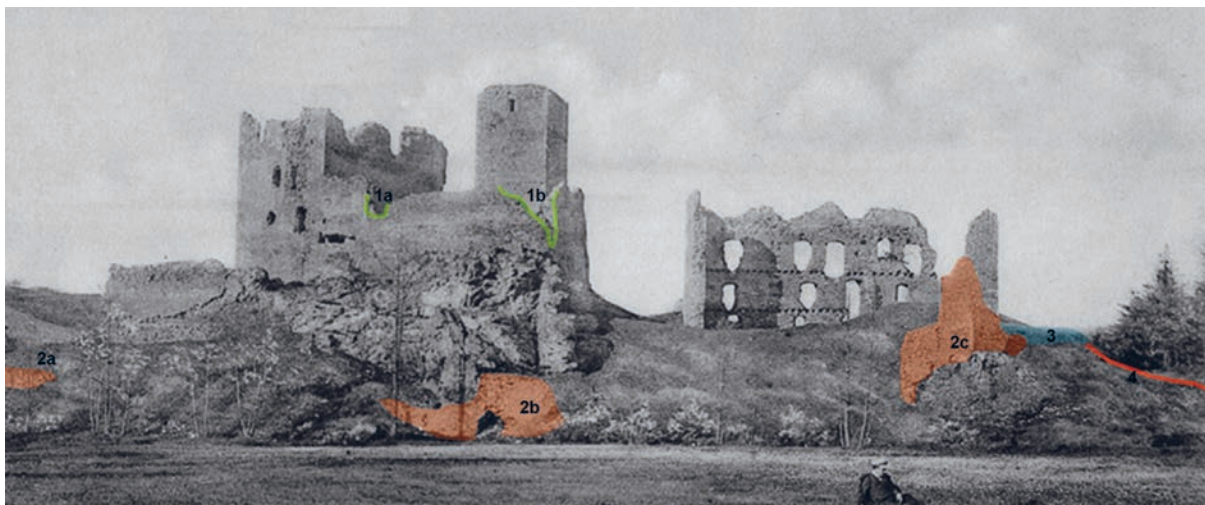
Fig. 9: Rokštejn, a postcard from 1906, 1a–b: destruction of the Upper Castle's wall, 2a–c: Zwinger wall with a polygonal corner, 3 remains of the Zwinger wall, 4 ditch.

The last owners, who saw the castle standing, were the Waldsteiners. They gained the Rokštejn castle into their ownership around the beginning of the 15<sup>th</sup> century and continued with the construction works on the castle. The active defence was moved to the newly built *Zwinger* wall, which has been preserved to this day only in three segments on western part of the castle (Fig. 9), and a substructure

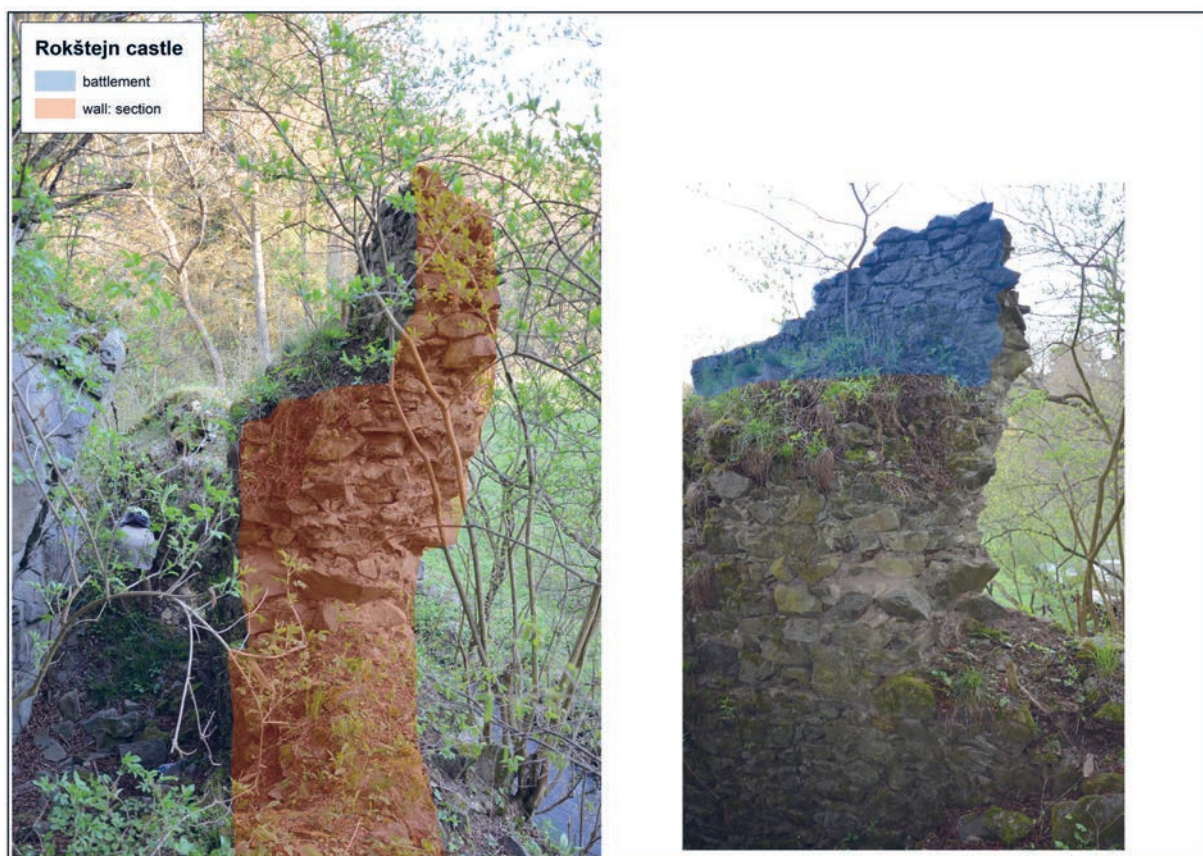
Fig. 10: Rokštejn, western Zwinger, Zwinger wall (part 2b on Fig 9) with a wall walk and battlement, see the narrow space between the rock and the wall, and relatively low height above modern terrain of 2,5 m.

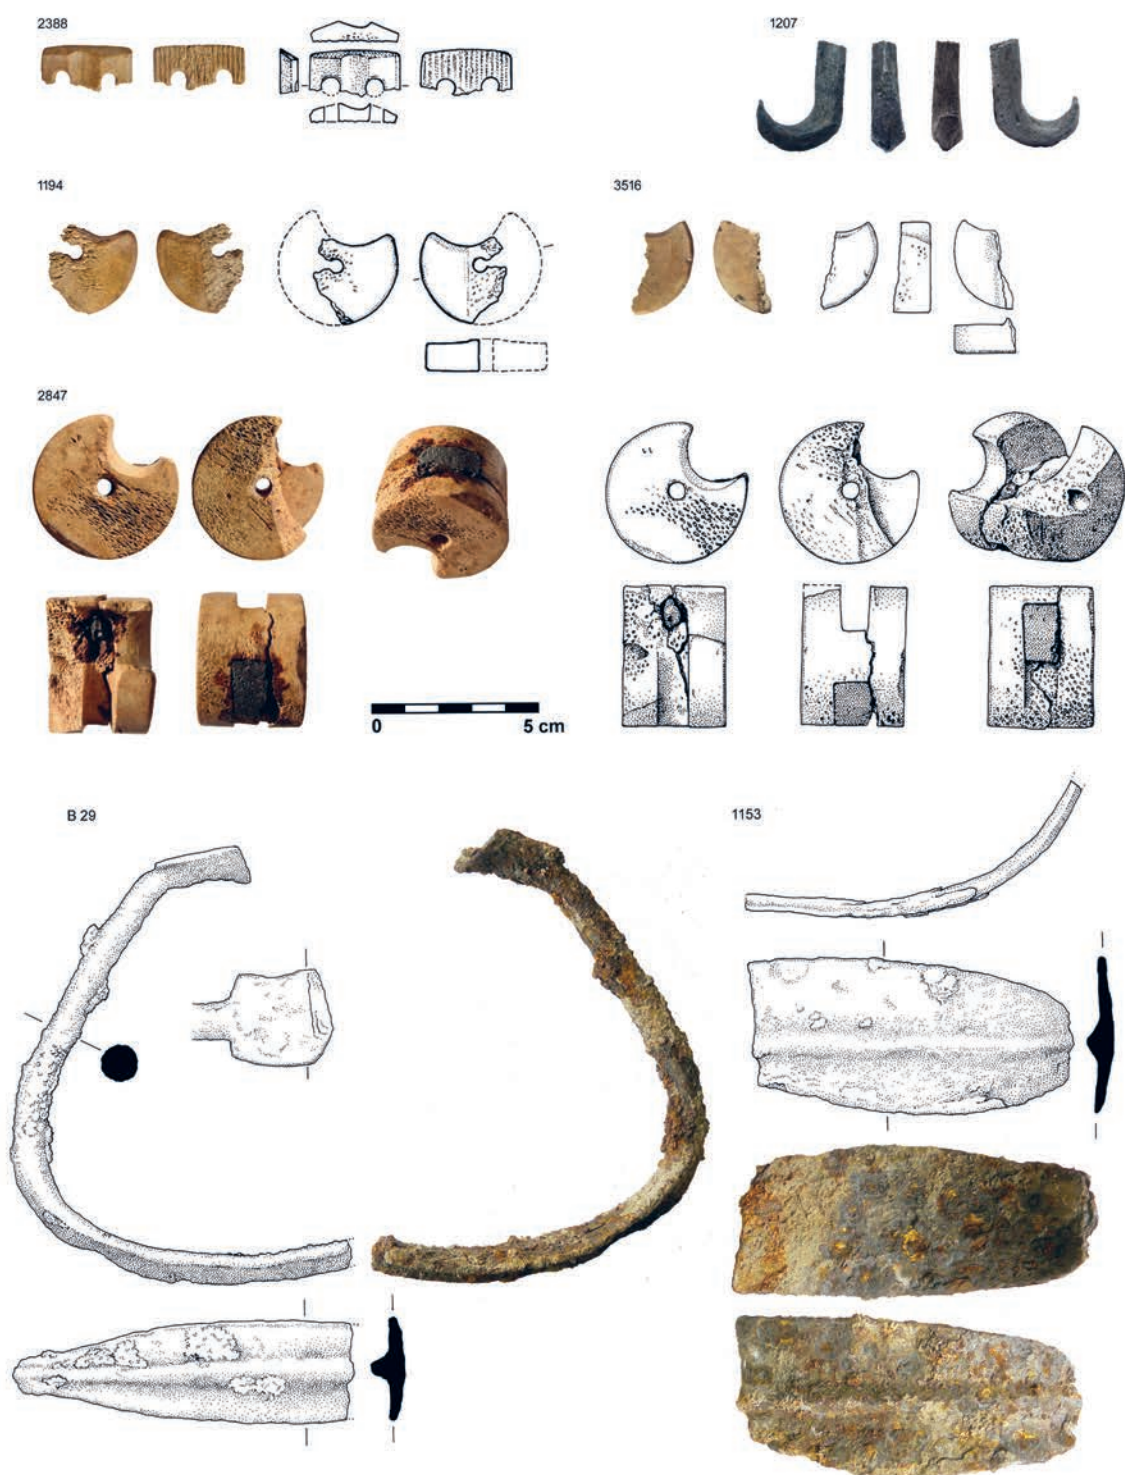
Fig. 12: Rokštejn castle, parts of the crossbow (bone plate with groove 2388, nut 1194, 3516, 2847, stirrup B29, 1153) and crossbowman equipment (spanning hook 1207).

When it comes to the crossbows, the research so far has yielded two crossbow stirrups, be it in only fragments (B29, A1153), bone table with groove, three roller releases (or nuts), or a spanning hook (Fig. 12 and Fig. 13).
